## TECHNICAL INFORMATION #920

### Re: IC- 7400/IC-746PRO Modification No.124

The following modification is regarding the improvement of IC-7400 and IC-746PRO.

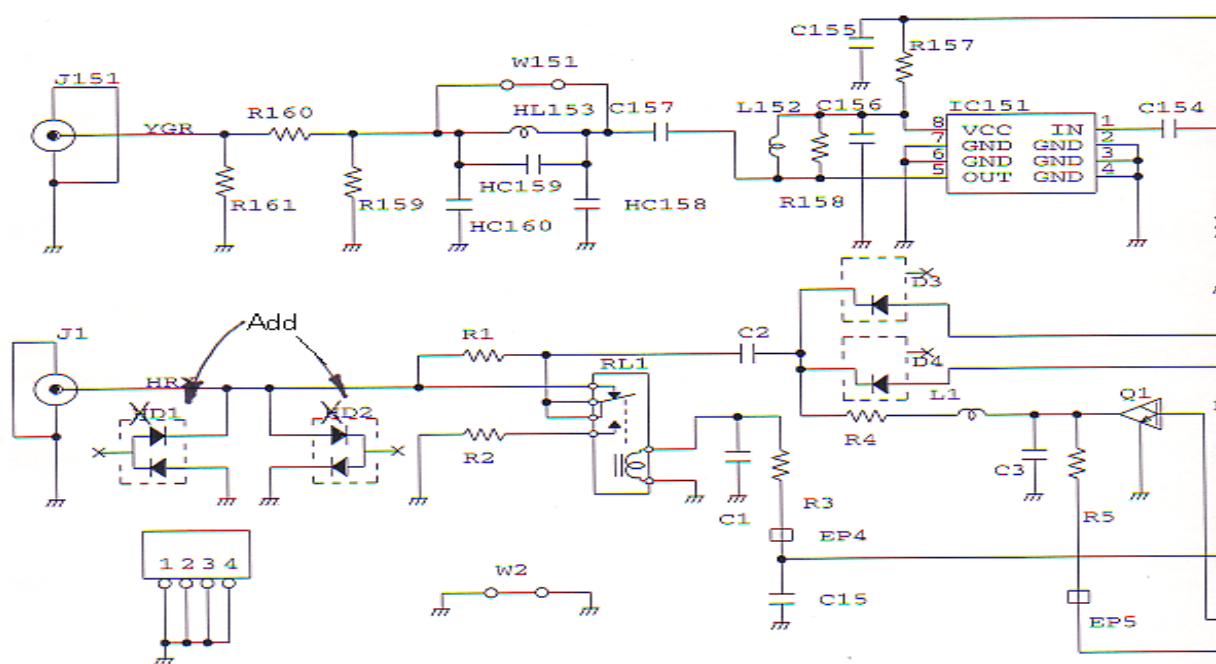
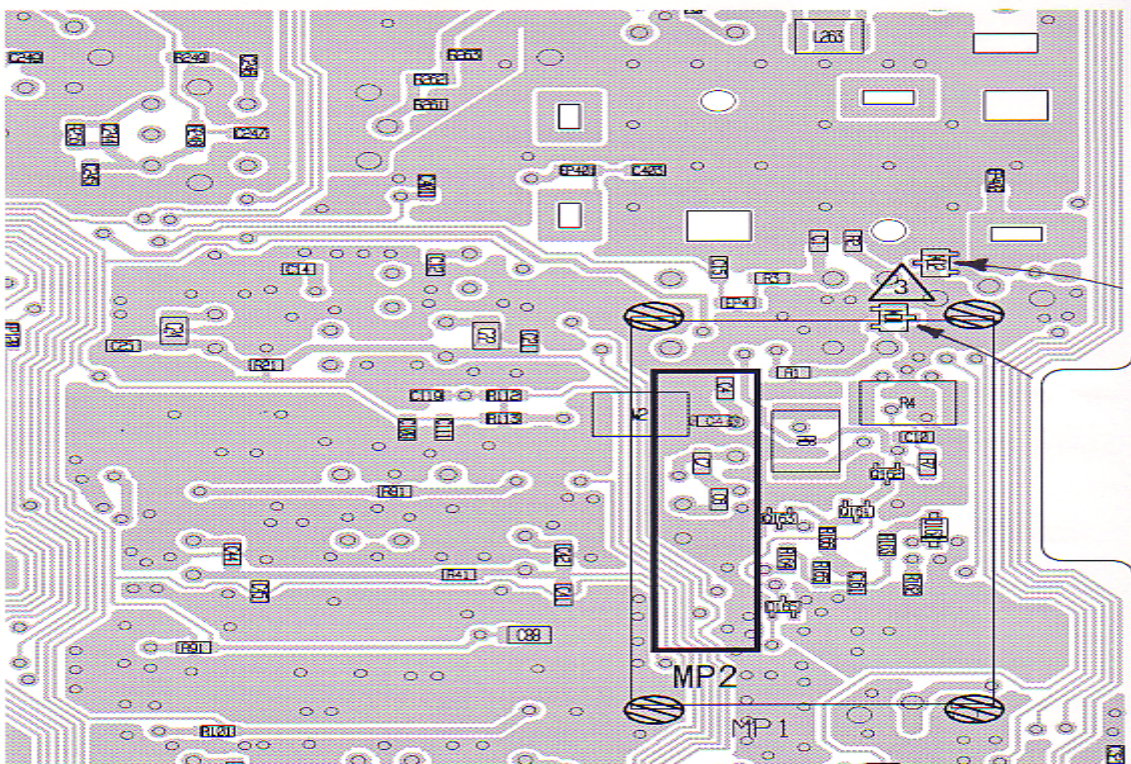
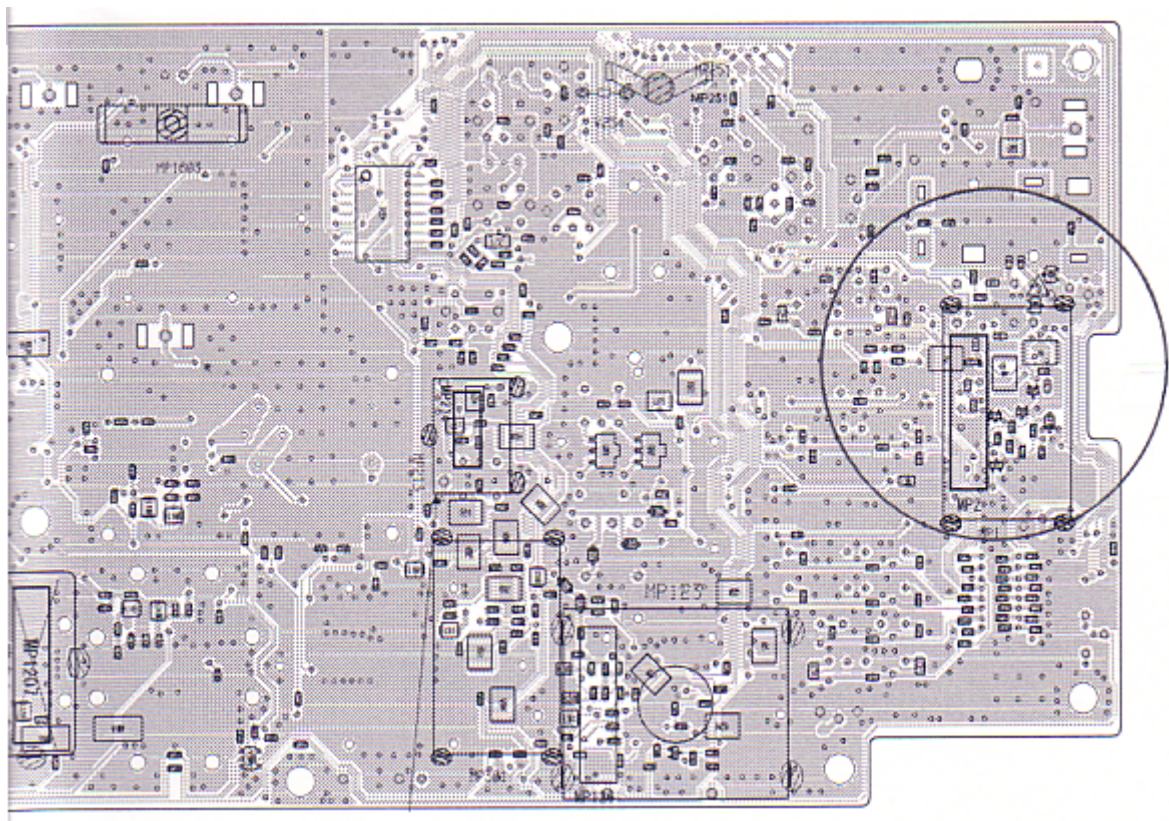
**Symptom:** No output power on the TX mode.

**Cause:** The IC151 is damaged because of static electricity.

**Solution:** Add two PIN diodes on receiving line as follows,
